# ROOF REBOOT TEST REPORT

ASTM E96 WATER VAPOR TRANSMISSION (DESICCANT METHOD), ASTM D3462 SECTION 8.1.7 PLIABILITY, AND ASTM D3462 SECTION 8.1.9 WEIGHT OF DISPLACED GRANULES (PER ASTM D4977) EVALUATION OF SHINGLES

N3762.01-106-31 R0

## TEST REPORT FOR ROOF REBOOT

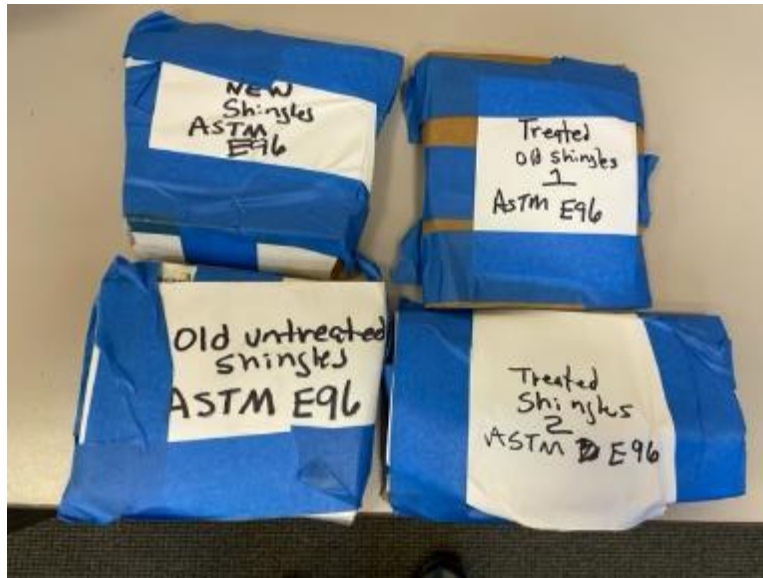
Photo No. 1  
Materials, As Received

The materials were provided by Roof Reboot. One box of ready to test asphalt shingle specimens was received in good condition on 02/15/22. Each set of specimens was identified as one of the following: 7 Year Old Shingles Treated with Roof Reboot, New Untreated Shingles, 15 Year Old Shingles Treated with Roof Reboot, and Untreated 15 Year Old Shingles. Refer to the product description photos in Section 9. Representative materials/test specimens will be retained by Intertek B&C for a minimum of four years from the test completion date.

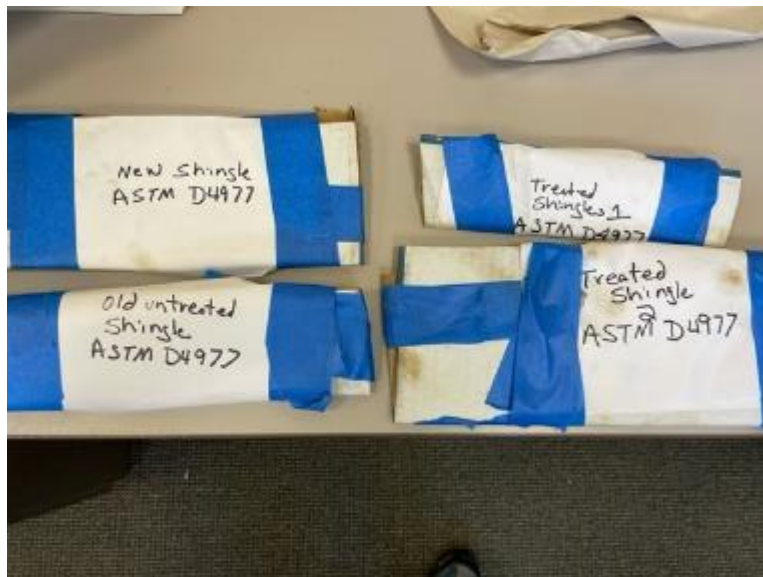
Photo No. 2  
Materials, As Received

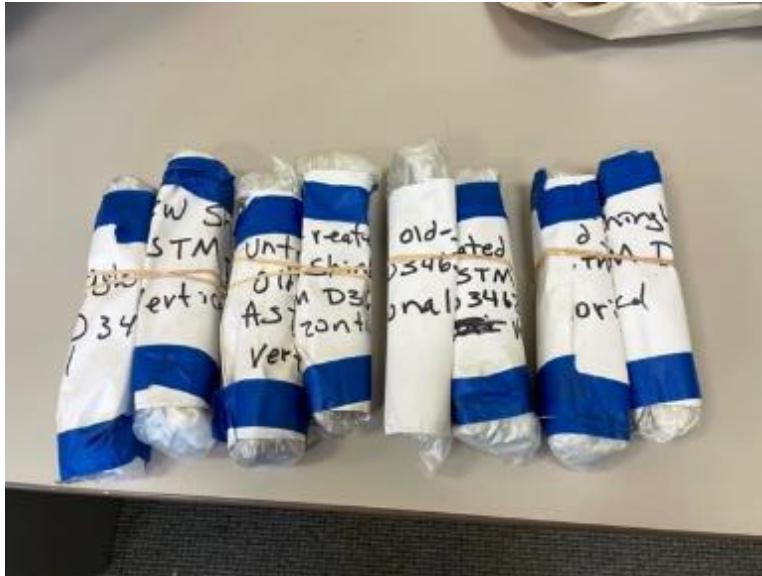
Photo No. 3  
Materials, As Received

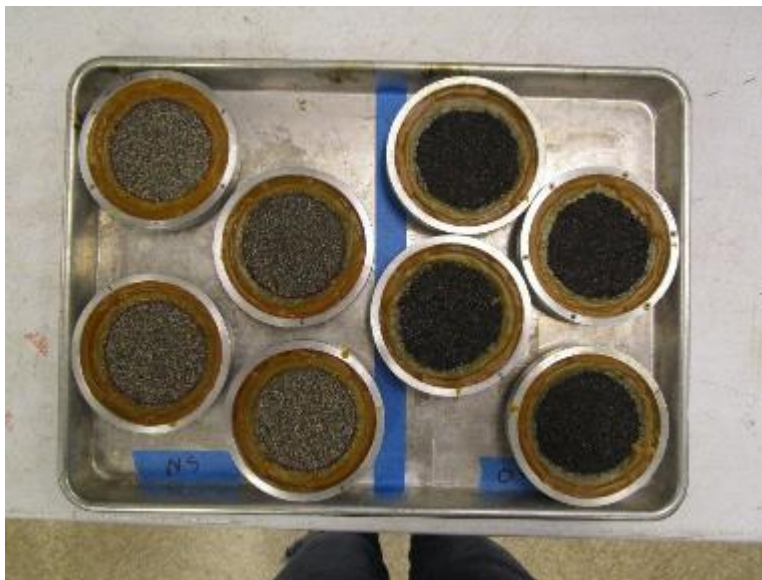
Photo No. 4  
ASTM E96 Water Vapor Transmission - Specimen Assemblies

The specimens were placed in an Espec environmental chamber (ICN: 005615) set at 23°C (73.4°F) and 50 ±2% RH for the duration of the test. The new treated shingles, new untreated shingles, and old treated shingles were removed from the environmental chamber once a day during normal business days for weight measurement. The old untreated shingles were removed from the environmental chamber six times a day during normal business days for weight measurement. The weights of the specimen assemblies were recorded utilizing a Mettler Toledo AX504 Balance (ICN: 003449). The environmental conditions were recorded at the same time. The water vapor permeance and transmission were calculated in accordance with the test method.

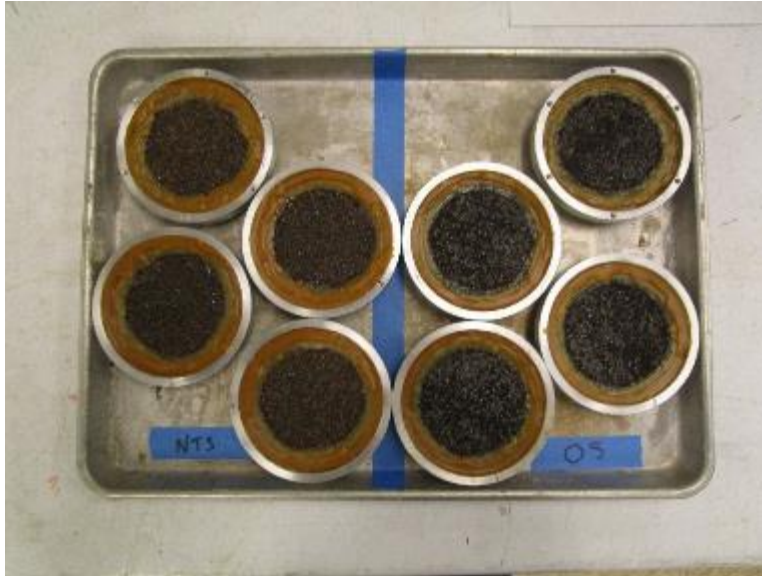
**Photo No. 5****ASTM E96 Water Vapor Transmission - Specimen Assemblies**

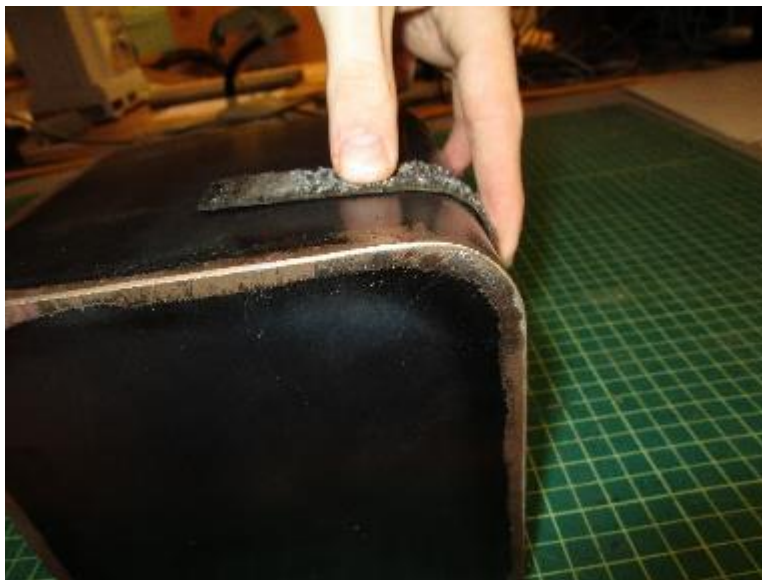
**Photo No. 6****ASTM D3462 8.1.7 Pliability - Test in Progress**

The specimens and a mandrel block with one edge rounded to a radius of 25 mm (1 in.) were conditioned at 23 ±2°C (73 ±4°F) for 2 ±0.1 hours. Testing was performed at 23 ±2°C (73 ±4°F). The specimens were bent at a uniform speed through an angle of 90° in 2 ±1/2 seconds over the rounded edge of the mandrel block, and then observed for cracking of the filled coating asphalt which exposes the reinforcement of the shingle or fracture through the specimen.

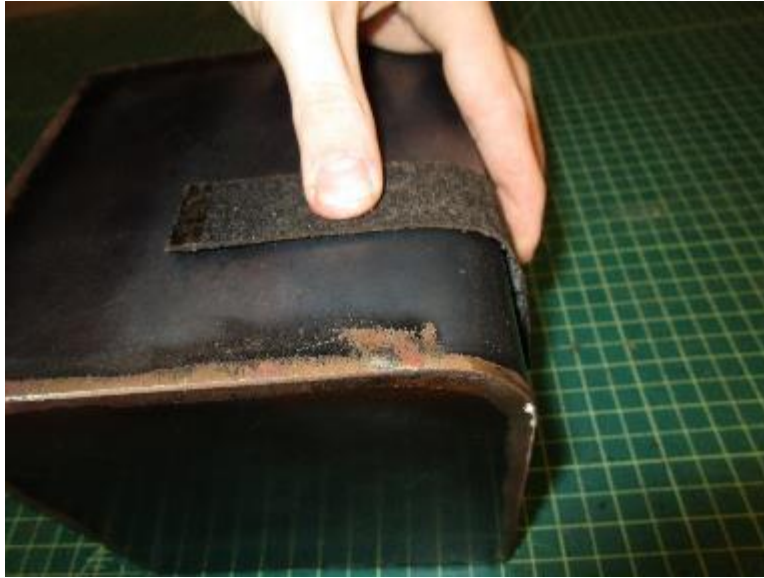
**Photo No. 7****ASTM D3462 8.1.7 Pliability - Test in Progress**

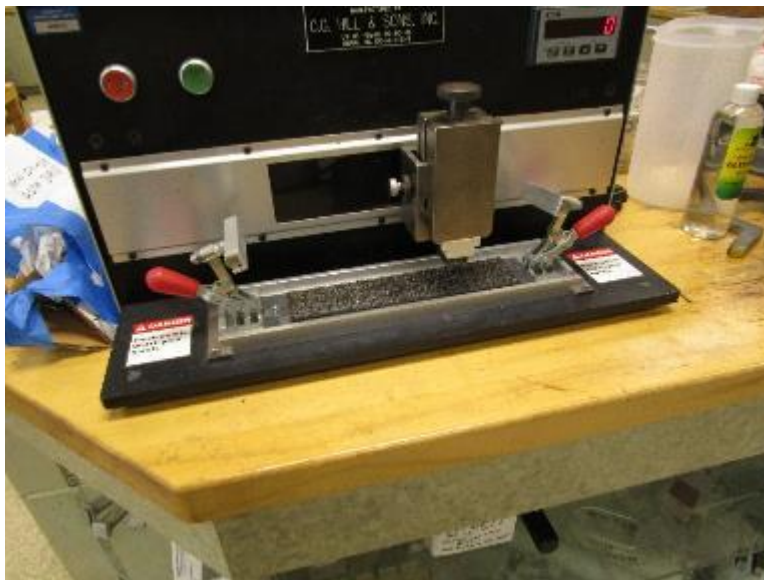
**Photo No. 8****ASTM D3462 Section 8.1.9 Weight of Displaced Granules - Test Set Up**
